"WHAT" S LEFT after a TORNADO

a project of the SCHOOL OF ARCHITECTURE
Lawrence Institute of Technology
Southfield, Michigan

supported by the DEFENSE CIVIL PREPAREDNESS AGENCY

July, 1975

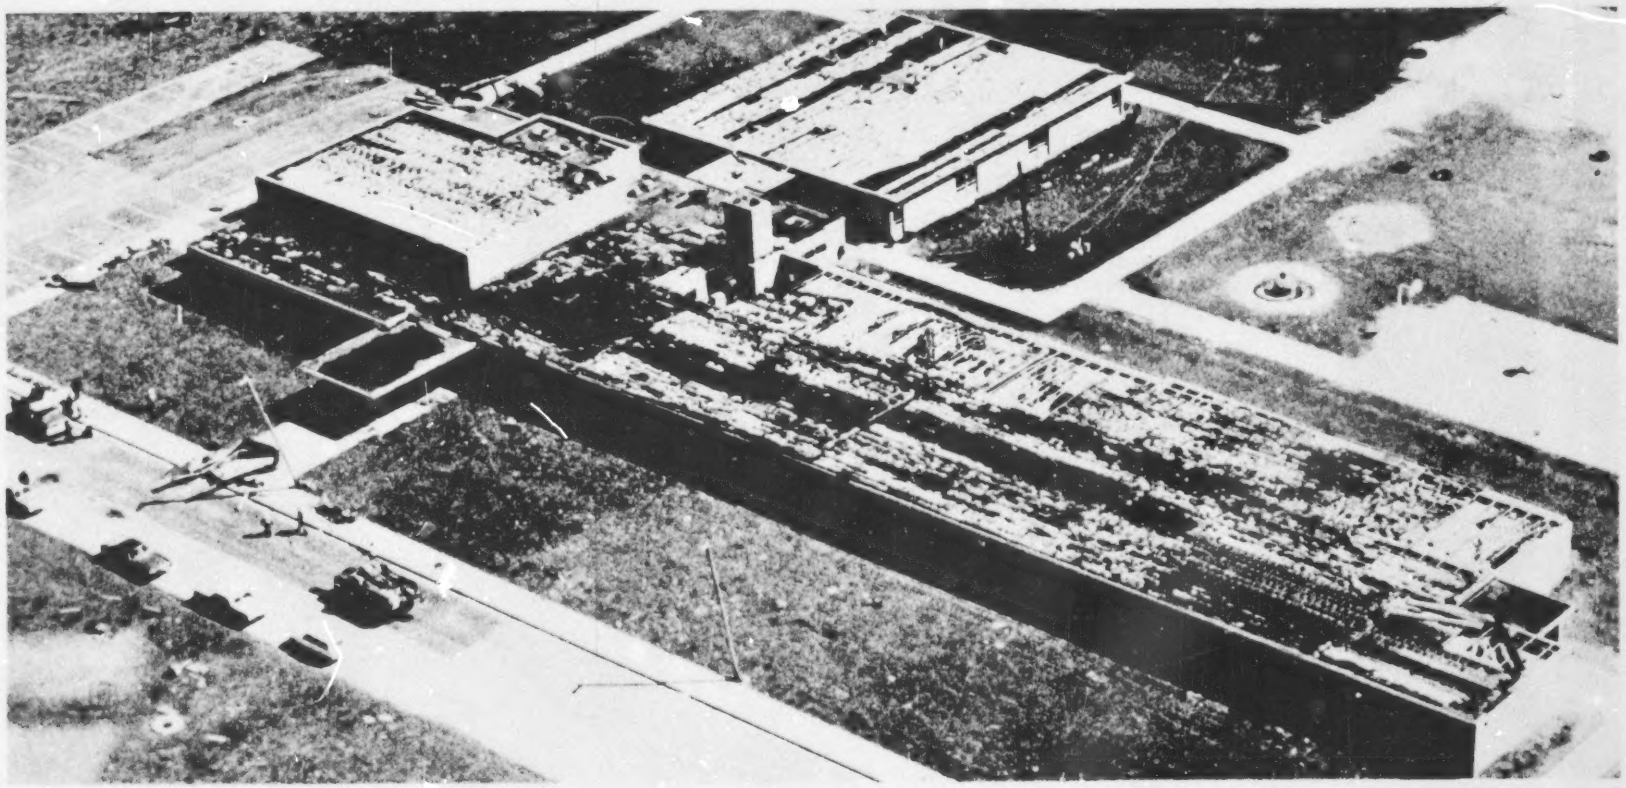
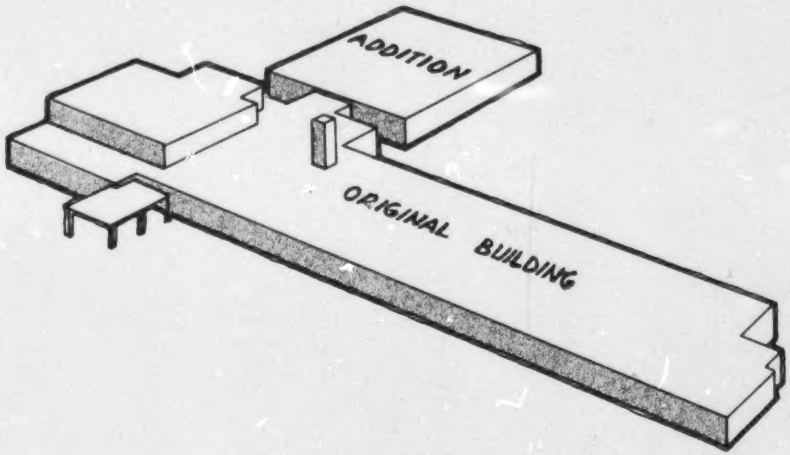
MEADOWLAWN ELEMENTARY SCHOOL

Unrepairable damage occurred to the original classroom wing when the south exterior walls failed. The *WINDOWS* blew into all of the *WINDWARD SIDE* classrooms. All south and west windows were broken. The wind entered these rooms causing a ballooning effect. Some of the metal roof deck was uplifted, landing throughout an open field northeast of the school.

The winds blew into the west facing classrooms, causing the furniture to be thrown around and to settle into cone-like piles in the center of the rooms.

The glass in the unbaffled south entrance blew throughout the corridor causing a *WIND TUNNEL*.

The winds in this corridor caused some of the roof decking to uplift.

The original 12 classrooms and library were demolished. The boiler room, multipurpose room, offices and the 6 classroom addition were repairable.

The *STEEL FRAME* remained intact.

The *INTERIOR PARTITIONS* stopped incoming missiles from reaching adjacent rooms or corridors.

North and East classrooms received little damage.

Roof fans lifted off the multipurpose room helping the pressure difference to equalize without serious damage.

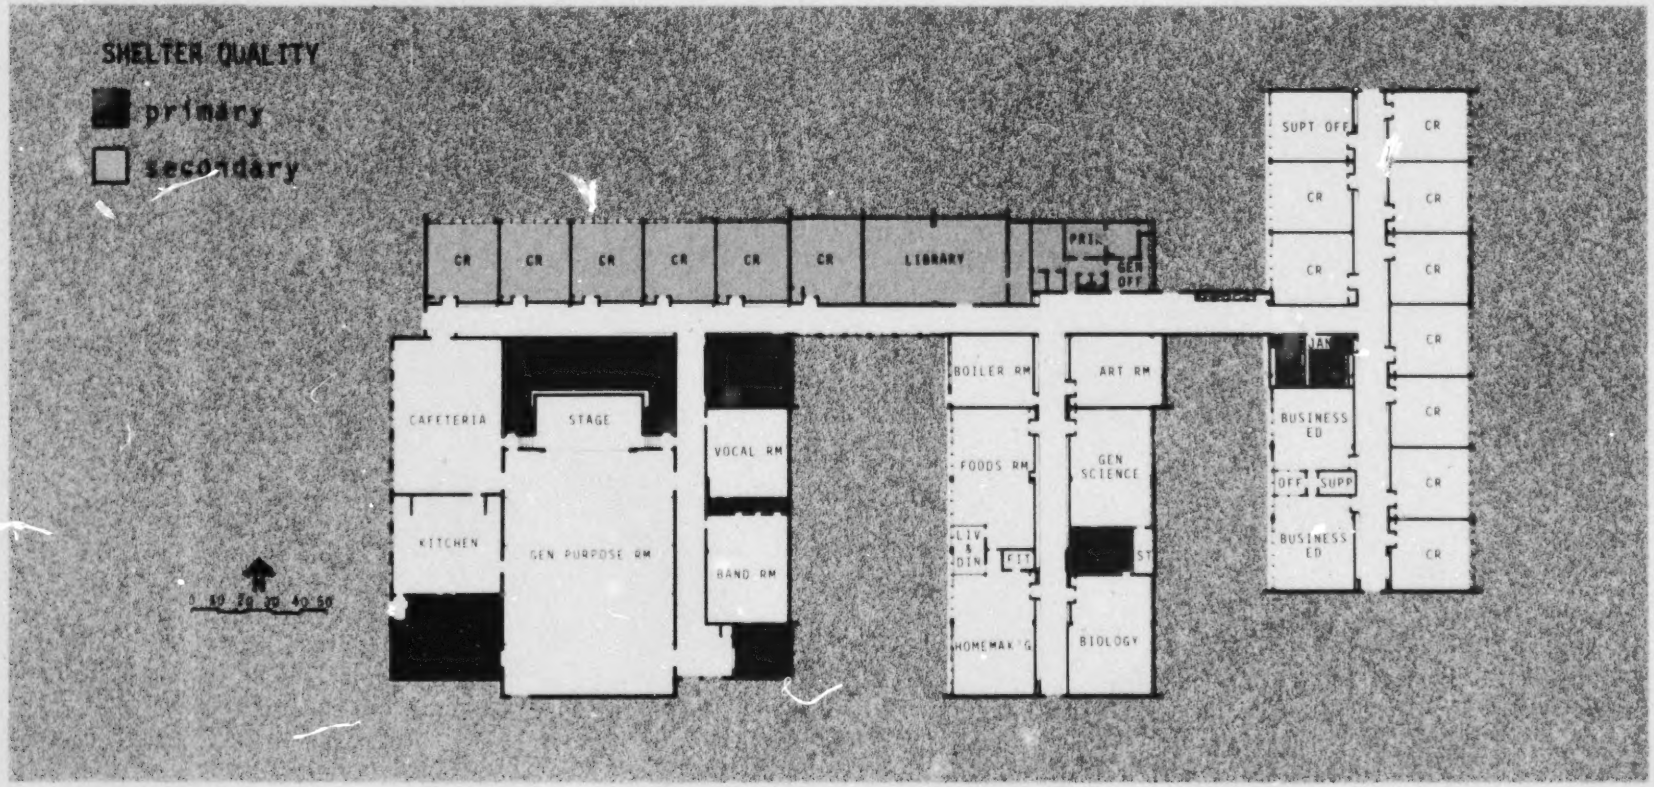
XENIA SENIOR HIGH SCHOOL

The enclosure walls failed on the west and south sides allowing the winds to enter the building. The roofs collapsed over the 3 large spans; auditorium, boy's gym and girl's gym. The lightweight roof over the original 2-story building was removed.

All *WINDOWS* on the *WINDWARD SIDES* (west and south) were blown into the interior. The high single-story, *LOADBEARING MASONRY WALLS* of the *LONG SPAN* rooms failed, allowing the roofs to fall in. The unbaffled west entrances allowed the east-west corridors to become *WIND TUNNELS*.
